LAKE LINGANORE

NDI ID NO. MD-21

PHASE I INSPECTION REPORT
NATIONAL DAM INSPECTION PROGRAM

By
RUMMEL, KLEPPER & KAHL
Consulting Engineers
Baltimore, Maryland 21202

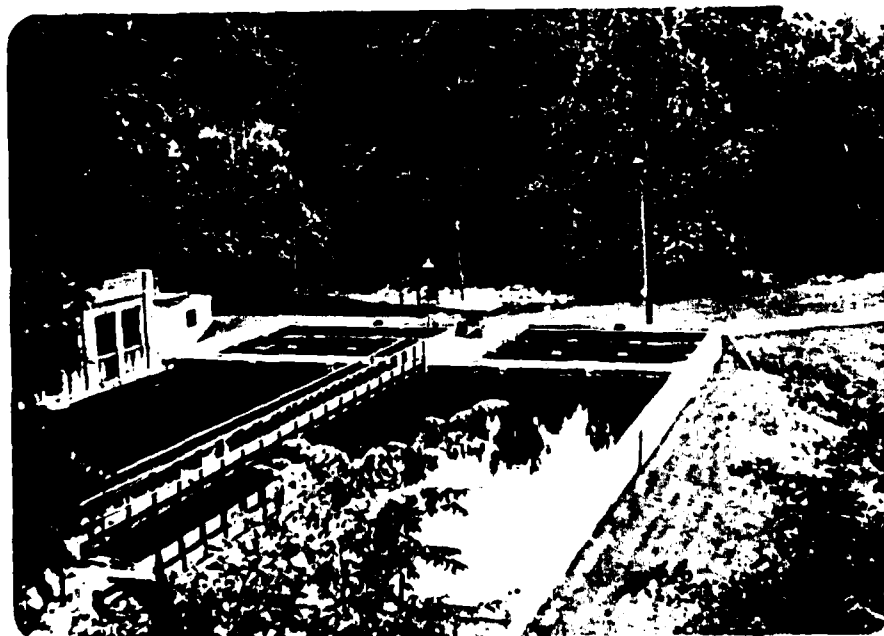
- (4) Downstream Conditions. Failure of the Lake Linganore Dam could cause serious damage to the 2.0-million gallon per day City of Frederick Water Purification Plant which is situated adjacent to Linganore Creek, approximately 1.8 miles downstream from the dam. During visual inspection of the purification facility, the plant operator reported that flood waters over topped the plant operating floor level during Hurricane Agnes. Failure of the dam could also cause flooding of two dwellings located between the dam and the purification plant. Based upon previous flood damage experience downstream from the dam, a dam failure would undoubtedly sever Eagleshead Drive, one of the few roadways connecting the north and south shores of the Lake Linganore development. Primarily because of the increased hazard of flooding downstream dwellings, and of the increased potential for serious damage of the City of Frederick Water Purification Plant, a high hazard classification is warranted for Lake Linganore Dam.

H. Frederick Filtration Plant along Linganore Creek
